CFB Comox Fire Fighting Training Area, PFAS Delineation and Water Treatment: A Case Study

May 10, 2019

- › [Doug McMillan](#), M.Sc., P.Ag.
Senior Project Manager, SNC-Lavalin Inc.

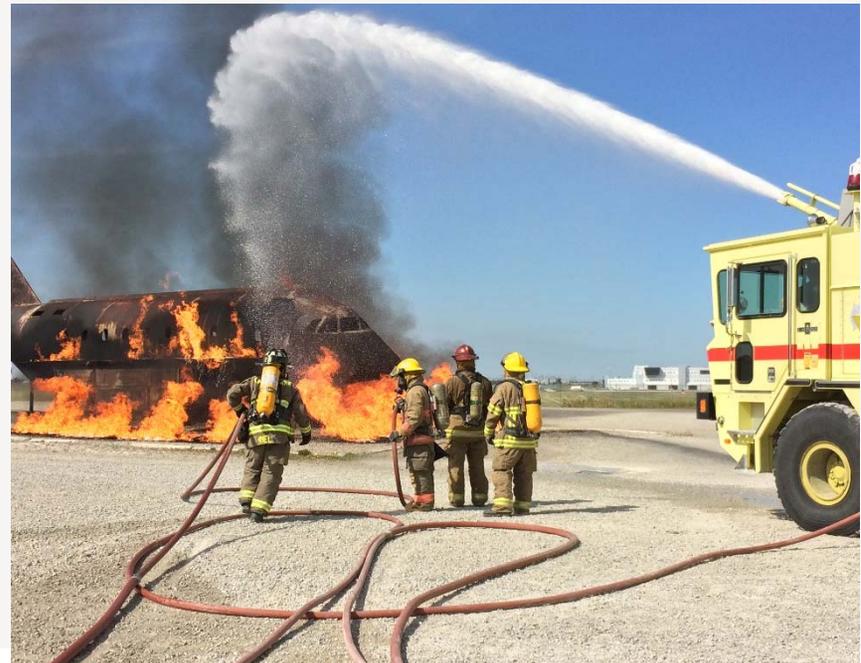
Background – CFB Comox FFTA, Site History

The Fire Fighting Training Area (FFTA) was first developed for training use in approximately 1968.

Some of the original features included:

- › Drive over waste oil pit.
- › Drummed fuel and oil waste storage.
- › Retention Pond (since 1960s).
- › Landfarm.
- › Burn area.

Oils, fuels, and other debris were burned during training exercises. Water and AFFF was used until ~2009.

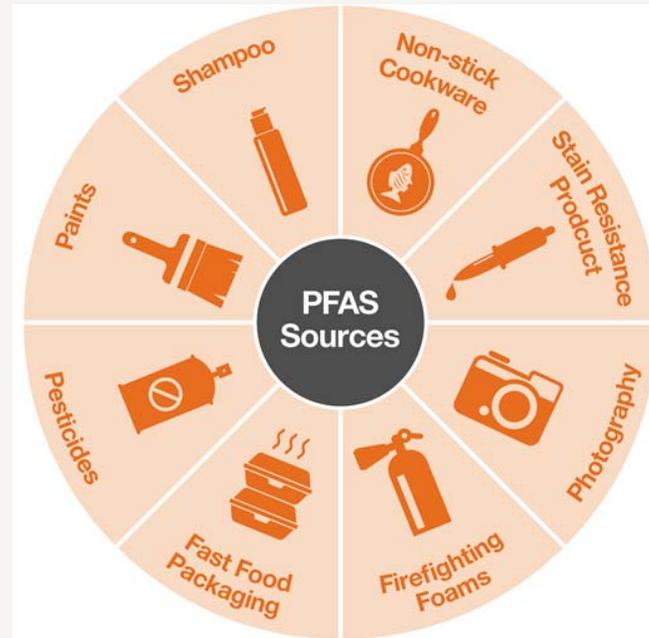
PFOA

PFOS

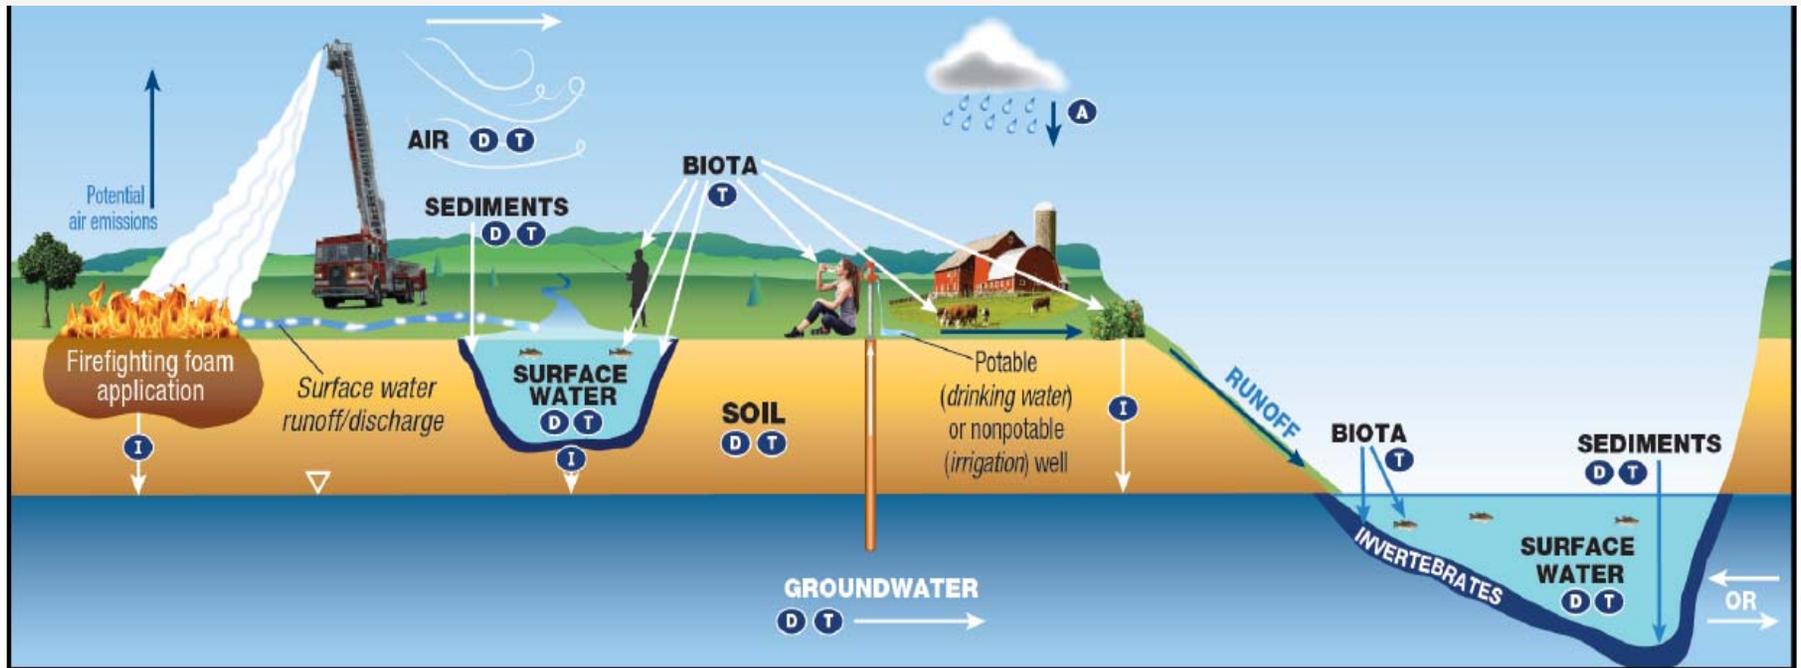
Site Setting – Graphical CSM

KEY **A** Atmospheric Deposition **D** Diffusion/Dispersion/Advection **I** Infiltration **T** Transformation of precursors (abiotic/biotic)

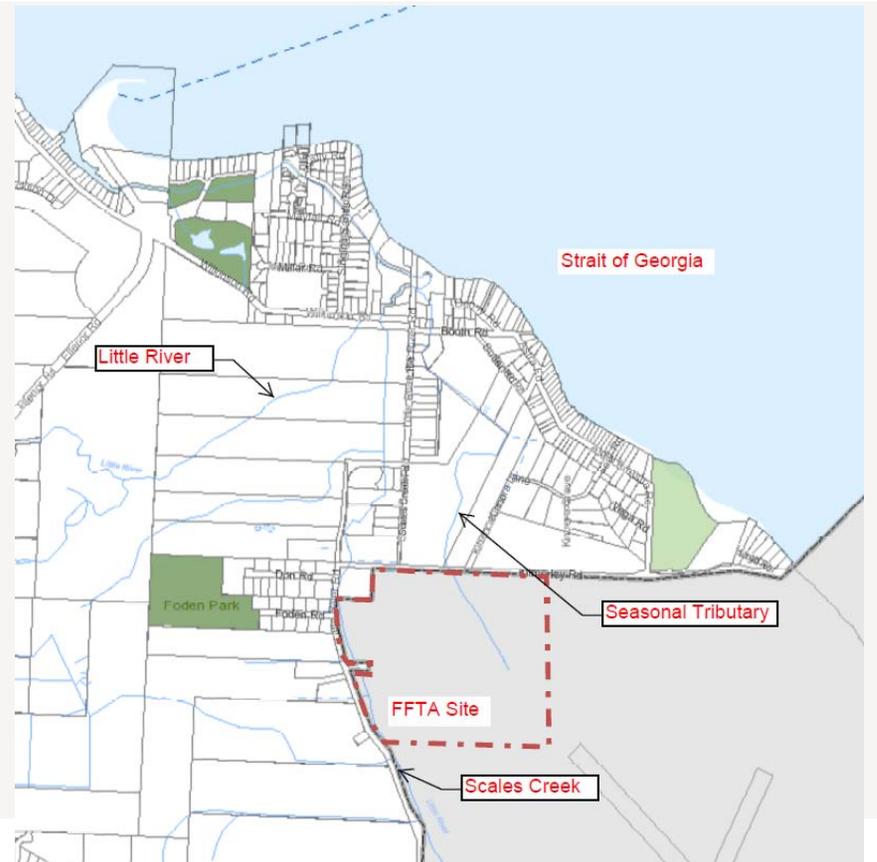
FFTA Site Location

- › The FFTA project site is located in the NW corner of CFB Comox.
- › The area is generally flat with surrounding area gently sloping to the north.
- › The land use around the FFTA is a mixture of residential, agricultural, light industrial, and commercial.
- › Surface water bodies include the FFTA retention pond, a seasonal tributary, and Scales Creek which are all part of the Little River watershed.
- › Soils are thin deposits of silt overlying dense silt till. The upper silt unit is seasonally saturated and the lower till unit has low permeability.
- › Numerous private water wells exist in surrounding areas.
- › Surface water drains from the FFTA towards the retention pond and swale and then directed north to a ditch on Kilmorley Road.

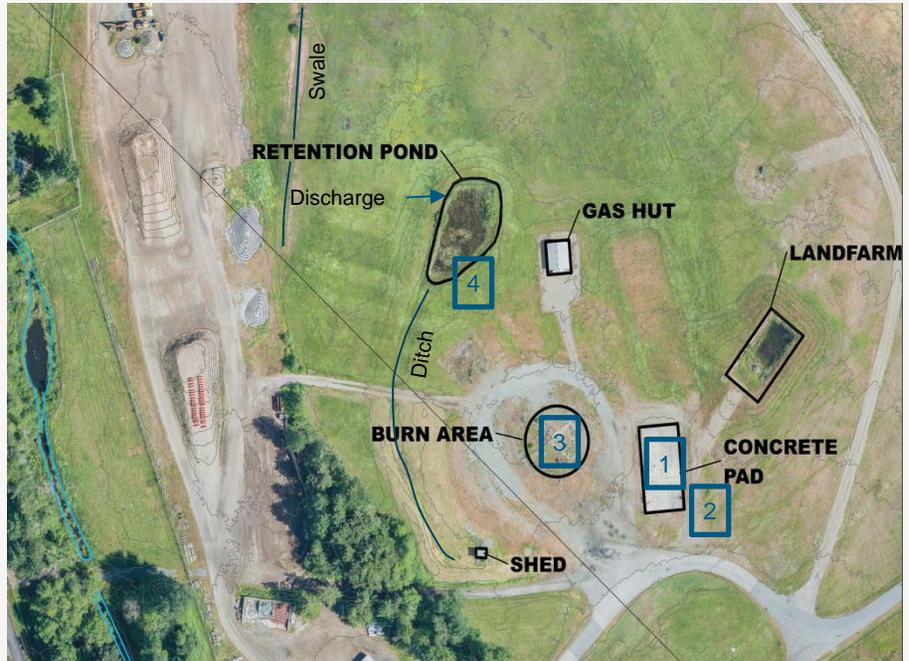
Previous reports identified 4 main contaminant sources

- › 1) Historical hydrocarbon storage in oil tanks.
- › 2) Historical waste oil pit.
- › 3) Historical fire fighting training (deposition of fuels and AFFF).
- › 4) Waste water generated from fire fighting training.

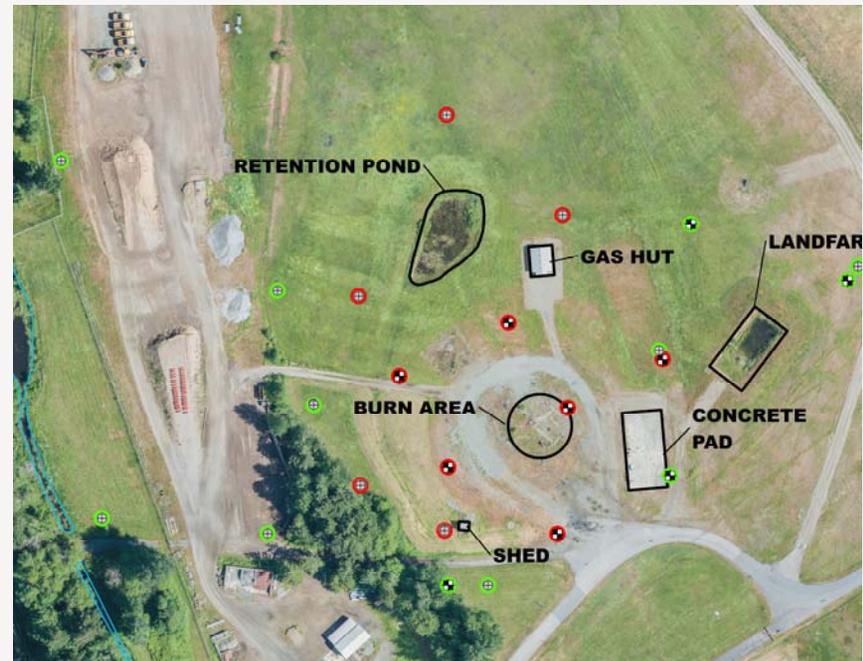
Prior Environmental Quality

Soil:

- › Soil COCs include BETX, F2-F4, PAH, arsenic, and PFOS greater than federal guidelines.
- › Centered around FFTA area in all directions.
- › Generally undelineated vertically and laterally.
- › PFOS was the only PFAS compound greater than guidelines and generally found within top meter but extending to a depth of 2.5 m within the FFTA.

Groundwater:

- › PFAS plume undelineated vertically and laterally.
- › VOCs present near former waste oil pit.
- › Dissolved metals are wide spread and undelineated.

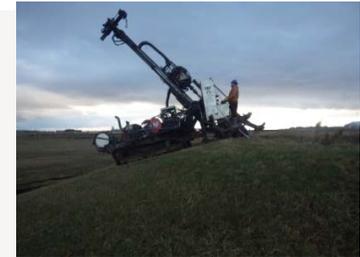
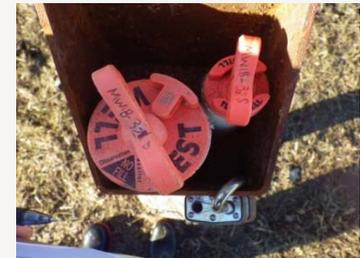
PFAS Sampling Methodology

Drilling and Soil Sampling

- › Hydrovac pre-clearing of boreholes.
- › Drilling and well installation with auger or sonic drill rig.
- › Soil sampling from auger flights or sonic cores.
- › Use of PFAS free containers.

Groundwater Sampling

- › Samples collected with a peristaltic pump and new HDPE tubing.
- › Sampling anticipated low concentration wells first and progress toward high concentration PFAS wells.
- › Samples collected in laboratory prepared jars.

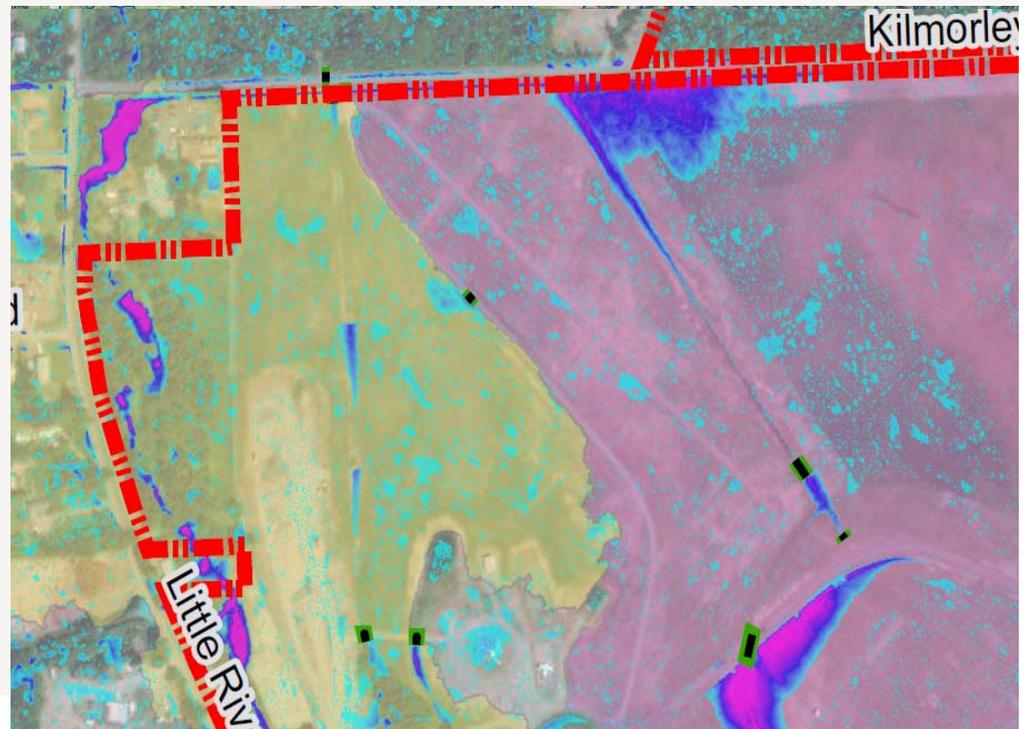
- › Used available LIDAR data to map surface water flow across the site.
- › Stratigraphy identified as a thin deposit of silt overlying a dense silt till (with varying sand, clay, and gravel).
- › Groundwater and surface water is highly seasonal with high water and flows in wet winter/spring months and low water and flows in dry summer/fall months.
- › LIDAR data shows surface flow migrating toward the north/northwest.
- › Two distinct sub-catchments are visible separated by a road.
- › Storage areas/depressions are shown by the blue to bright pink.

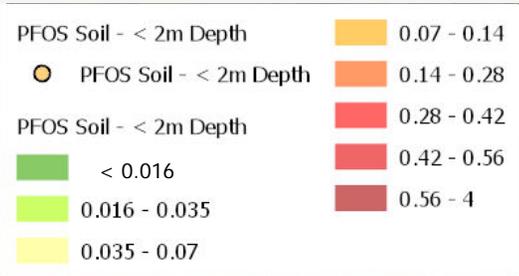
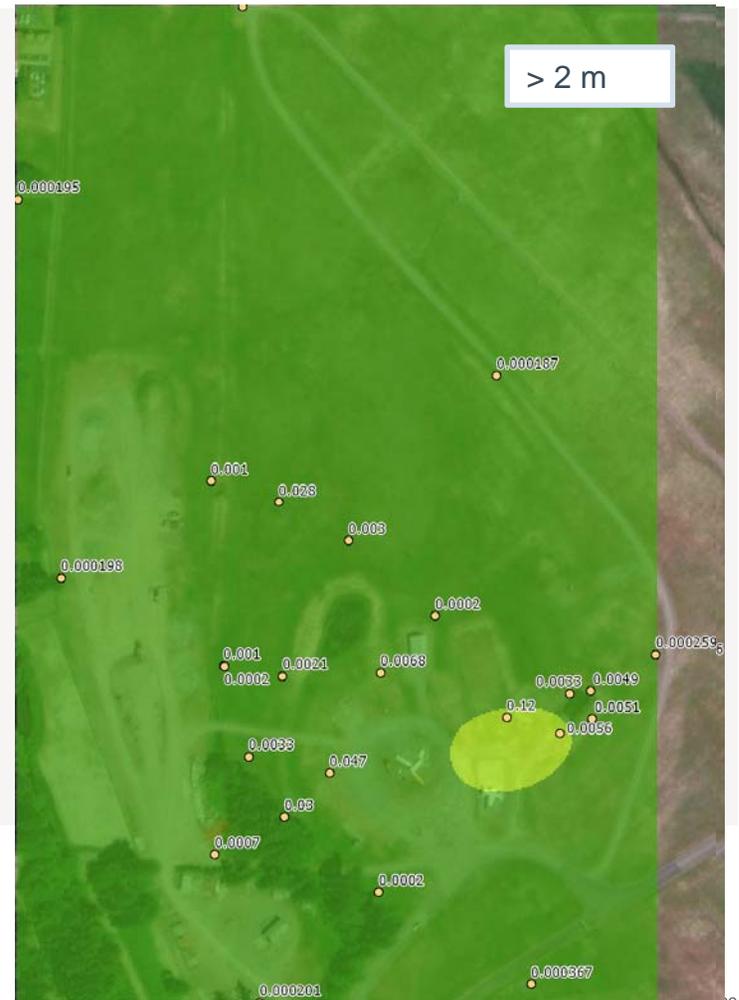
- › Concentrations of PFOS were identified greater than the CCME Draft Soil Guideline (0.14 mg/kg).
- › All other PFAS compounds were less than the available guidelines and screening values.
- › Concentrations of PFOS were plotted using the ArcGIS Kernel Interpolation with Barrier analytical tool.
- › Map Results were plotted at 3 different depths
 - › 0 to 1 m;
 - › 1 to 2 m; and,
 - › > 2 m.
- › The 2018/2019 field activities were generally successful at delineating PFAS and other COCs.

- › PFOS and all COCs successfully delineated in soil.
- › PFAS compounds in groundwater extend to site boundaries to the north, northwest, and are not fully delineated to the southwest, or south within CFB Comox.
- › GW delineation is ongoing and not yet complete.
- › Offsite investigations being completed by others.

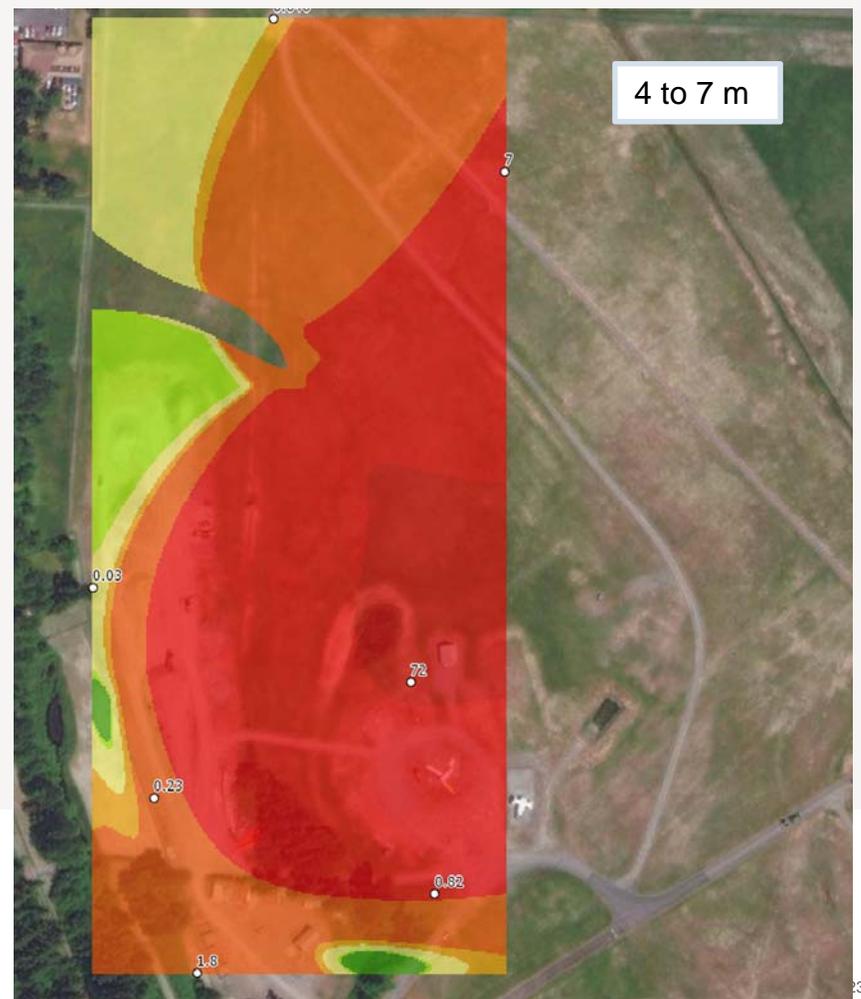
- › Concentrations of several PFAS compounds were identified greater than the available drinking water guidelines.
- › Concentrations of PFOS were plotted using Inverse Distance Weighting methods.
- › Map Results were plotted for 3 different screen depths
 - › 0 to 2 m;
 - › 2 to 4 m; and,
 - › 4 to 7 m.
- › Following 2018/2019 field activities concentrations of PFAS compounds greater than drinking water guidelines were undelineated to the north, west, southwest, and south to the property lines.
- › Offsite investigations are being completed by others

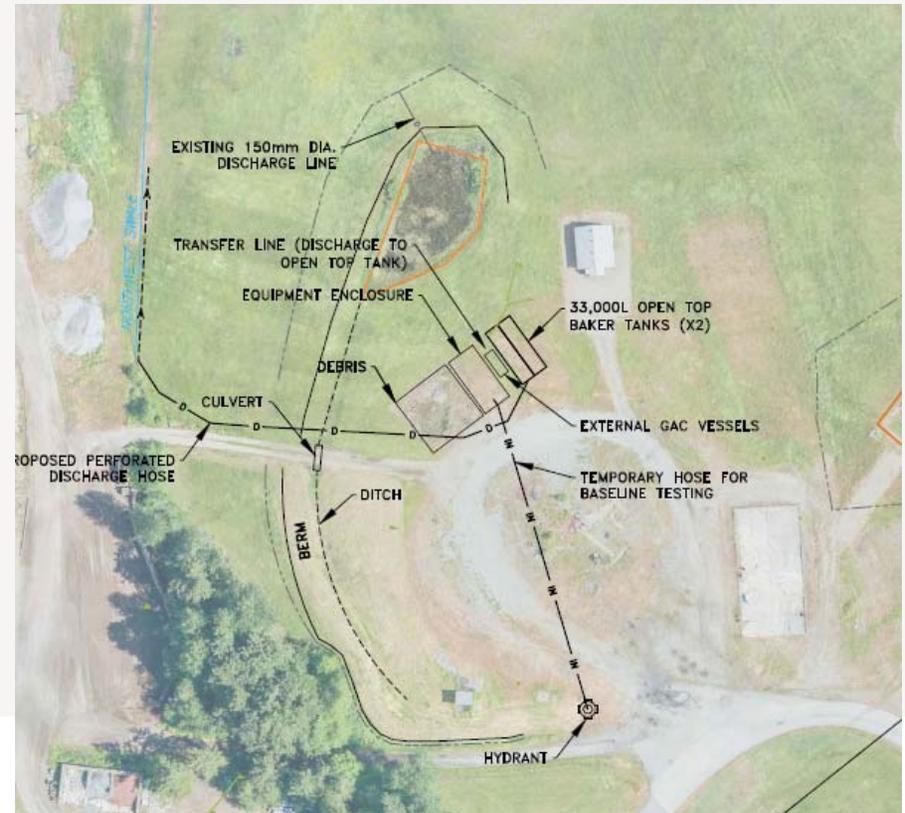
- › Evaluation of existing MPE system at a BC Airport.
- › System was inspected on October 19, 2018.
- › Using a crane and transport subcontractor, the equipment was loaded on December 19, 2018 and delivered to CFB Comox on December 21, 2018.
- › System was re-purposed to water treatment at CFB Comox and the following equipment was set up:
 - › 2 x Bag Filters.
 - › 2 x 110 kgs Carbon Vessels.
 - › 3 x 225 Kgs Carbon Vessels.
 - › Pumps and flow meters.
 - › 2 x 33,000 L Baker Tanks (open top).
 - › 6 kVA generator with secondary containment.

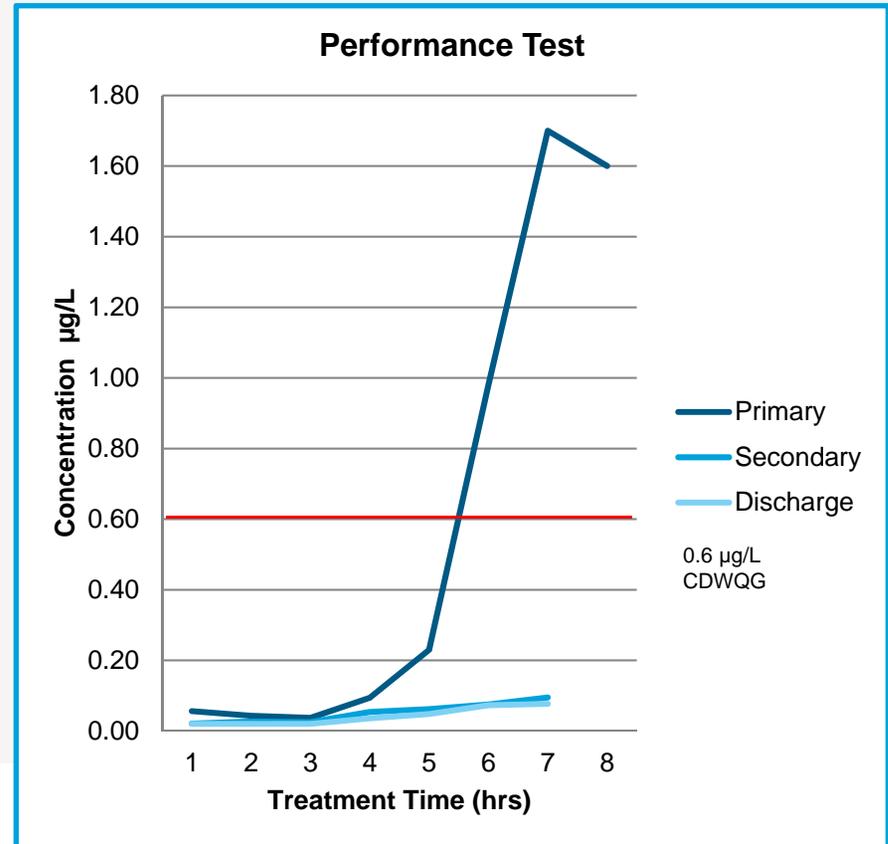
- › Baseline testing of system with 19,000 L of PFAS free water.
 - › Analytical results post treatment were less than laboratory detection.
- › GAC performance review (2019).
 - › Treatment of 34,000 L of FFTA pond water using MPE, bag filters, and three liquid-phase GAC vessels.
 - › Pond inlet pump was screened to protect biota.
 - › Objective to observe break-through of PFAS compounds.
 - › Sample collection and analysis from three points in the system.
 - › *Primary – After 1st Carbon Vessel*
 - › *Secondary – After 2nd Carbon Vessel*
 - › *Discharge – After 3rd Carbon Vessel*
 - › Review sample results to determine maximum mass of PFAS that can be absorbed by the treatment system.

- › Potable water trial successful; PFAS results were non-detect.
- › GAC performance testing completed with pond water. Breakthrough achieved after first carbon vessel.

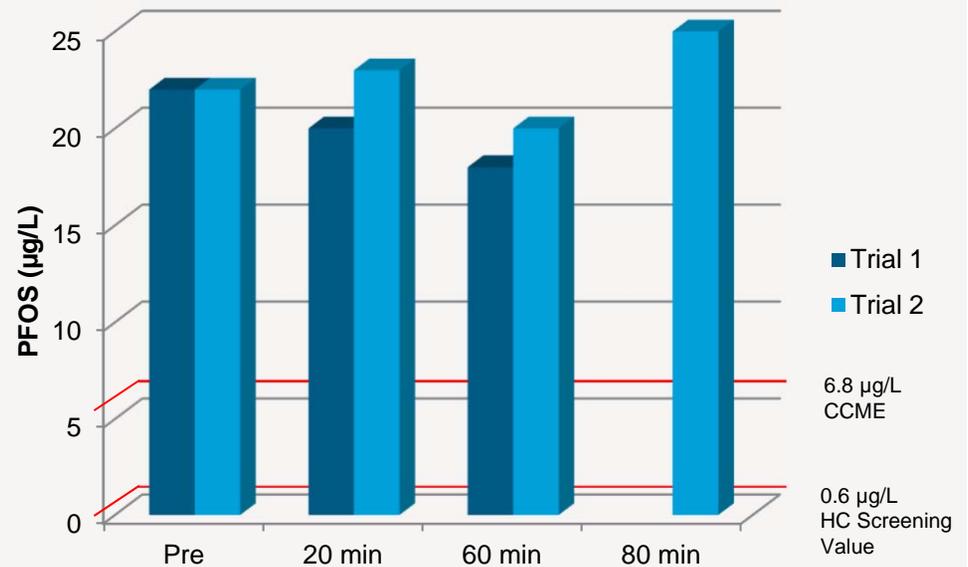
- › Selective chemical oxidation through reactions with hydroxyl radicals using proprietary chemicals.
- › Two trials completed:
 - › Pre-treatment with oxidant and citric acid.
 - › Trial 1, 60 minute circulation with 50 L of pond water.
 - › Trial 2, 80 minute circulation with 50 L of pond water, with post treatment sulphite solution and sodium hydroxide.
- › Sample analysis:
 - › Trial 1 – Pre-treatment, 20 min, Post-treatment
 - › Trial 2 – Pre-treatment, 20 min, 60 min, Post-treatment
 - › Trial 2 post treatment also analyzed for toxicity

- › Minor reduction of PFAS observed in Trial 1 and no reduction seen in Trial 2.
- › Results suggest that the treatment method was not viable to achieving regulatory compliance.
- › No toxicity observed in untreated water.
- › Toxicity observed in treated water likely due to amendments and increased Cd, Cu, SO₄, Na.

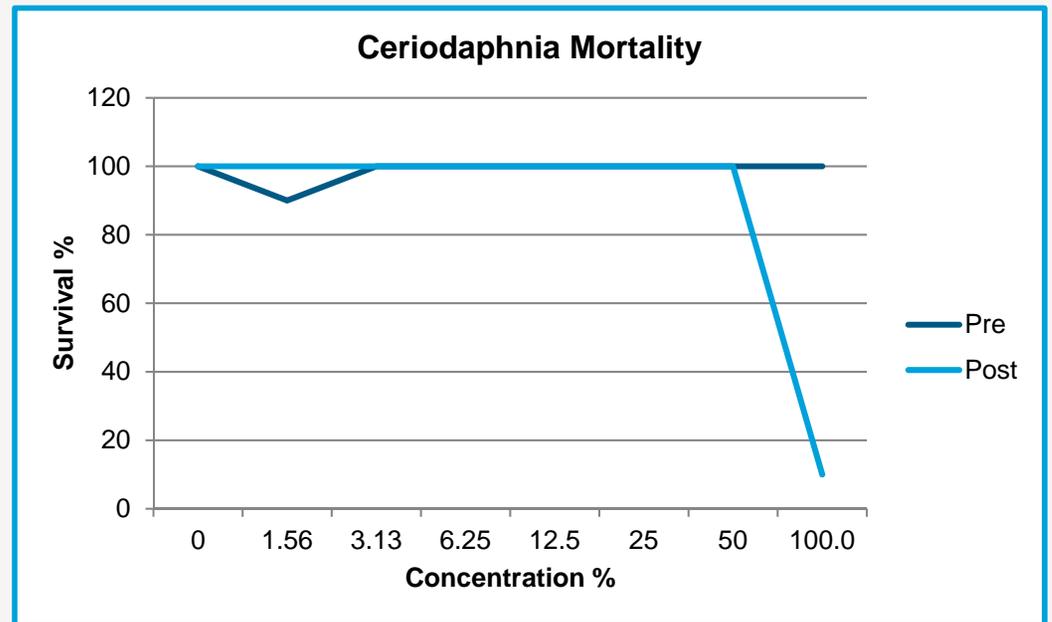
Rainbow Trout LC50 Toxicity

- › Pre treatment – No effect.
- › Post treatment – No effect.

Ceriodaphnia dubia Sub-lethal Toxicity

- › 10 replications, mean individual counts at increasing concentrations.

Reproductive effect

- › Pre-treatment – no effect.
- › Post treatment – significant negative effect at 100%.

Mortality

- › Pre treatment – no effect.
- › Post treatment – significant negative effect at 100%.
